# CDF Operations Report

JJ Schmidt

22-DEC-2003

All Experimenters' Meeting

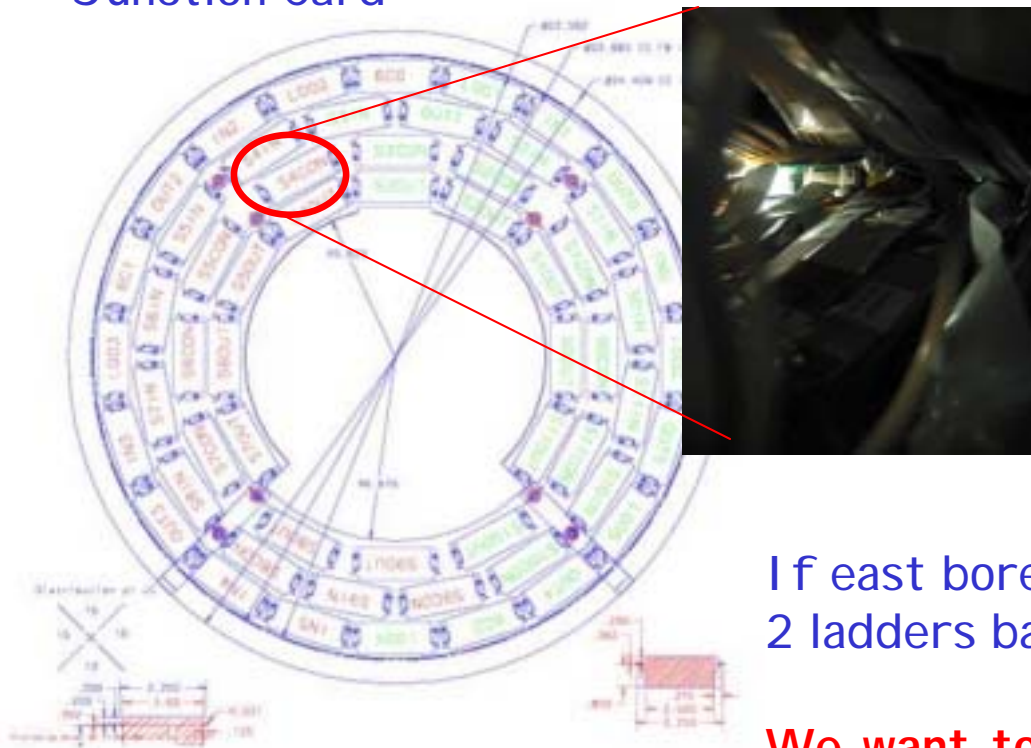
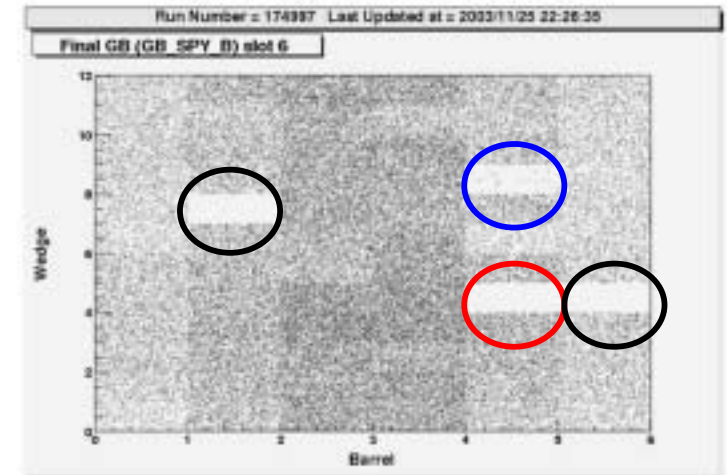
• One ladder death causes a hole in SVT coverage since two ladders are missing in that wedge.

- Likely common cause is a short in the Junction Card

Black - dead SVX wedges  
 Blue - 2 ladders dead in SVX wedge  
 Red - New hole due to 2 dead ladders

If east bore access is granted, we can get 2 ladders back - but the operation is tricky.

We want to go for it and need 2 shifts of bore access to do the job.
